Navajo Abandoned Uranium Mine

Site Screen Report

Cov000 AUM Site

Navajo AUM Northern Region

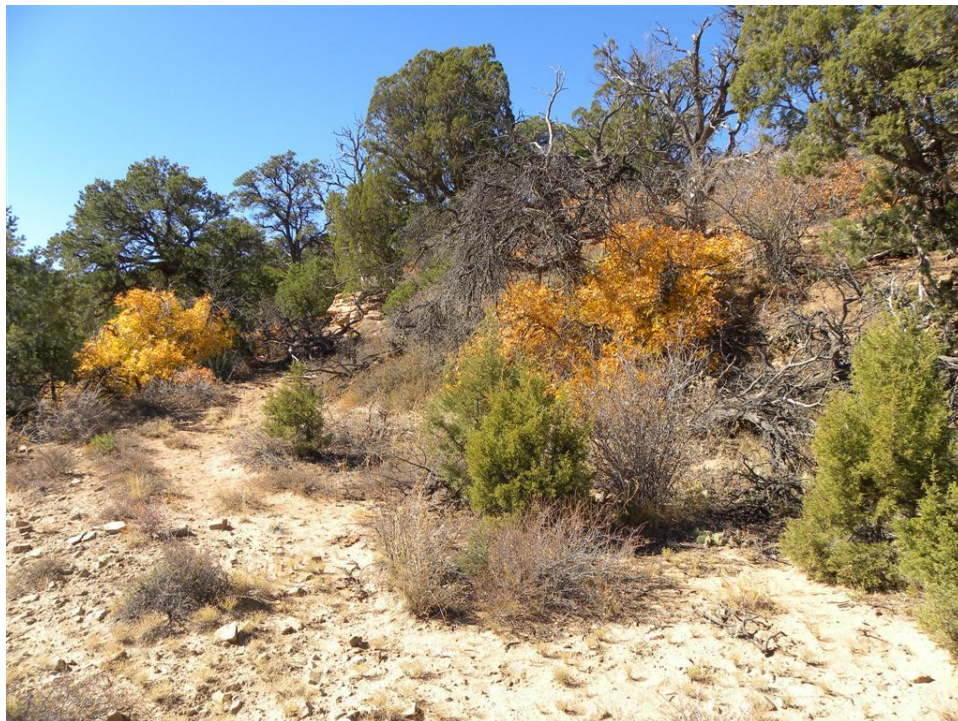
Photo 1. Mine site

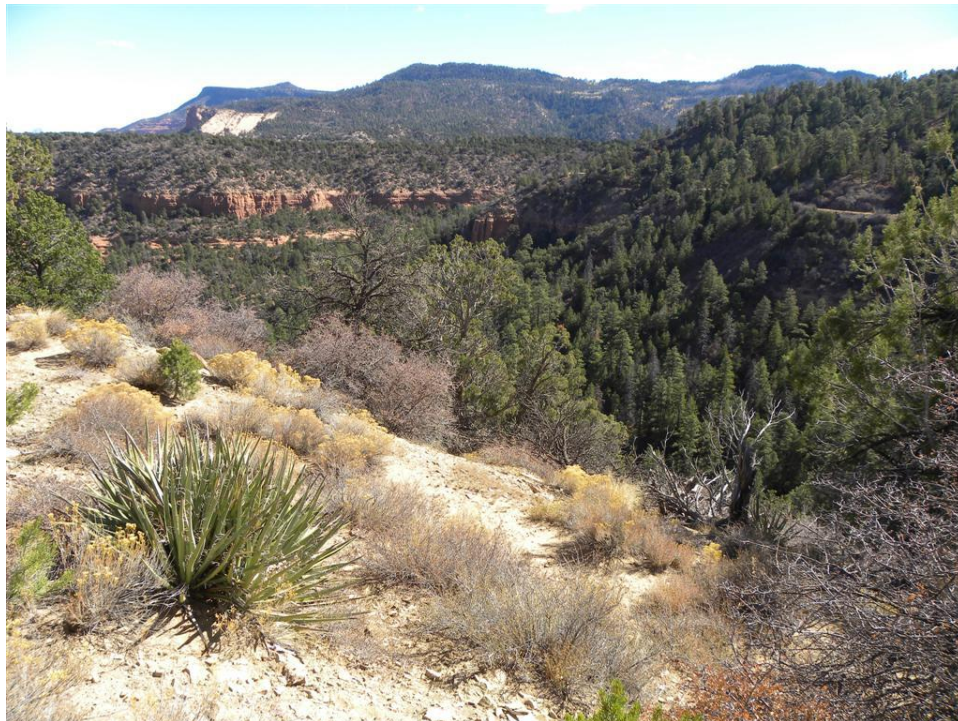
Photo 2. Mine site
